**RAILWAY INVESTIGATION REPORT**  
**R05E0008**

**CROSSING ACCIDENT**

**VIA RAIL CANADA INC.**  
**PASSENGER TRAIN NUMBER 1**  
**MILE 92.26, EDSON SUBDIVISION**  
**MACKAY, ALBERTA**  
**31 JANUARY 2005**

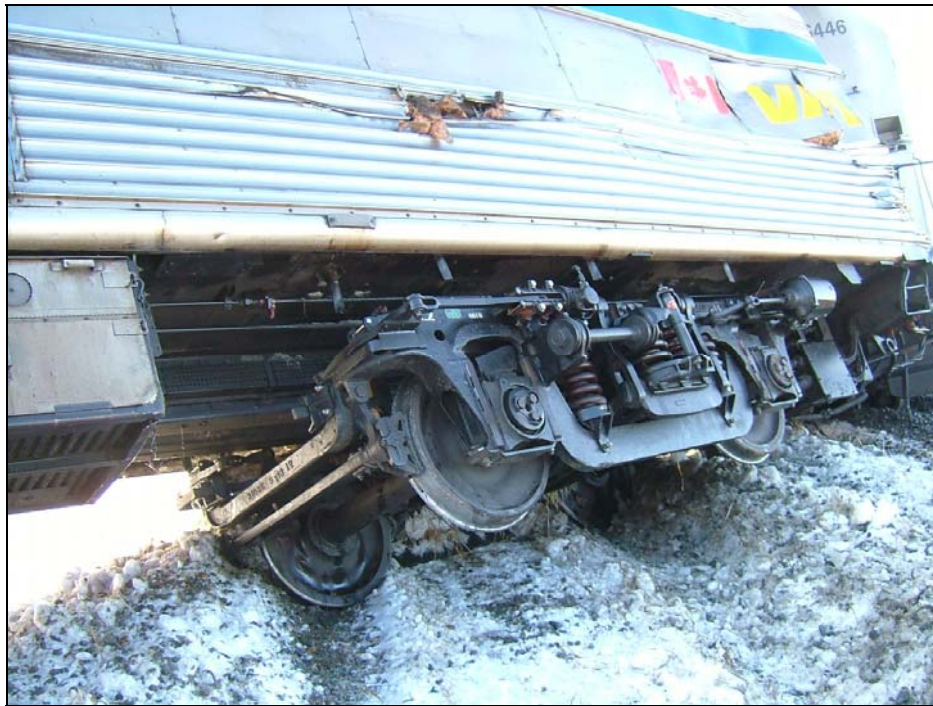
Both locomotives sustained significant damage that required removing them from service. The first three cars behind the locomotives came to rest at various angles and sustained significant damage. The remaining six cars stayed upright but derailed adjacent to the track, and all were damaged to some degree (see photos 1, 2, and 3).

**Photo 1.** View of damage to the north side of luggage car 8610

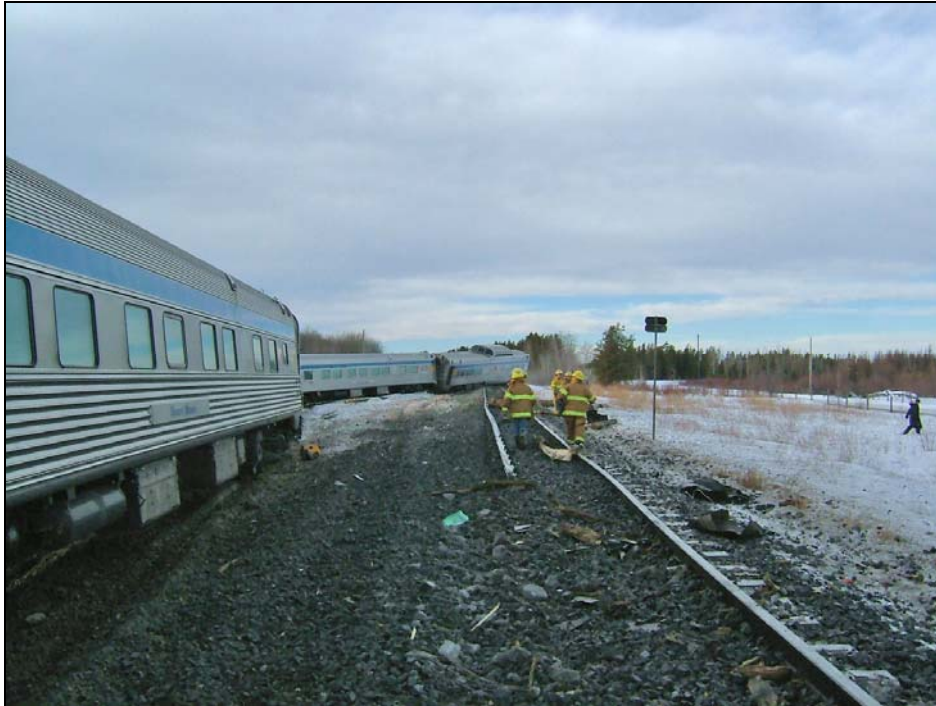
**Photo 2.** View of the derailment and associated track damage looking eastward from the crossing

Approximately 245 m of track west of the crossing required replacement.

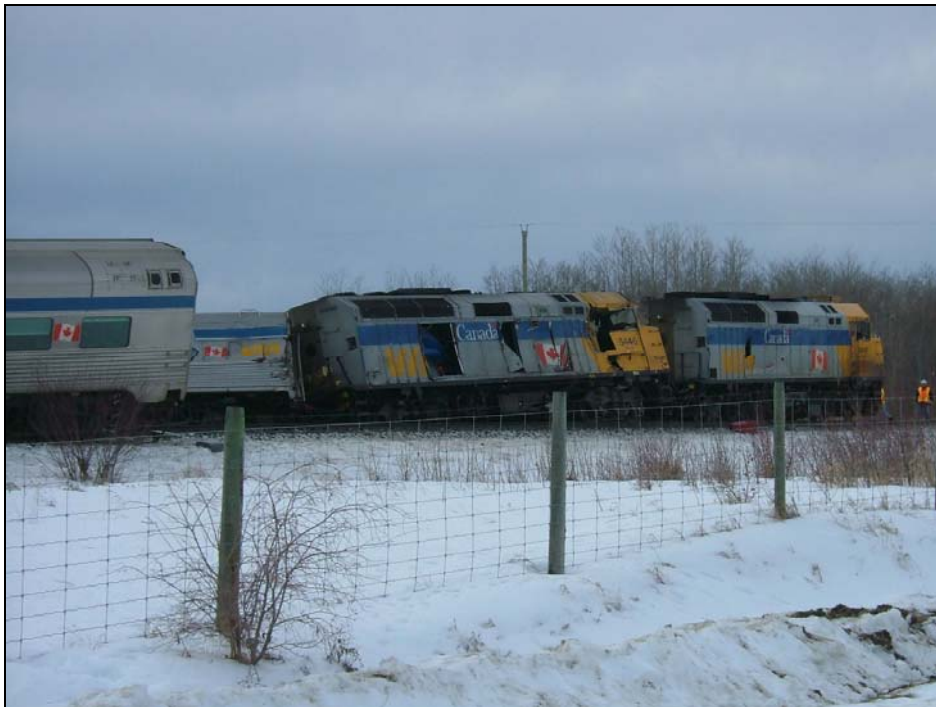
**Photo 3.** View of the damage to the north side of the two locomotives

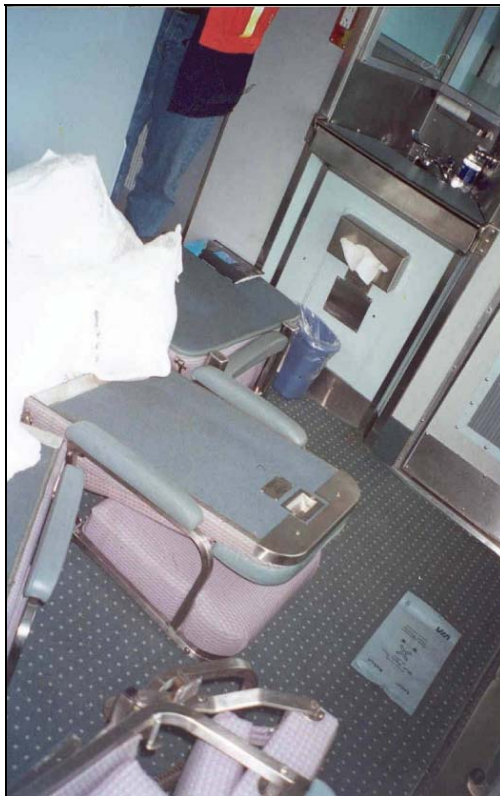
Specially designed windows provide occupants with emergency egress alternatives to the exit doors at the ends of the cars. Emergency exit windows are intended to remain freely accessible at all times. The armchair design increased the risk that an emergency exit would not be accessible. These large, heavy folding armchairs (weighing in excess of 66 pounds each) were not secured to the floor and slid around the sleeping compartments in cars 8717, 8340, and 8319. These chairs could have barricaded the doors, which are inward opening, and could have restricted access to the emergency exit windows in some of the sleeping compartments (see Photo 4).

**Photo 4.** Sleeping compartment with folding chairs

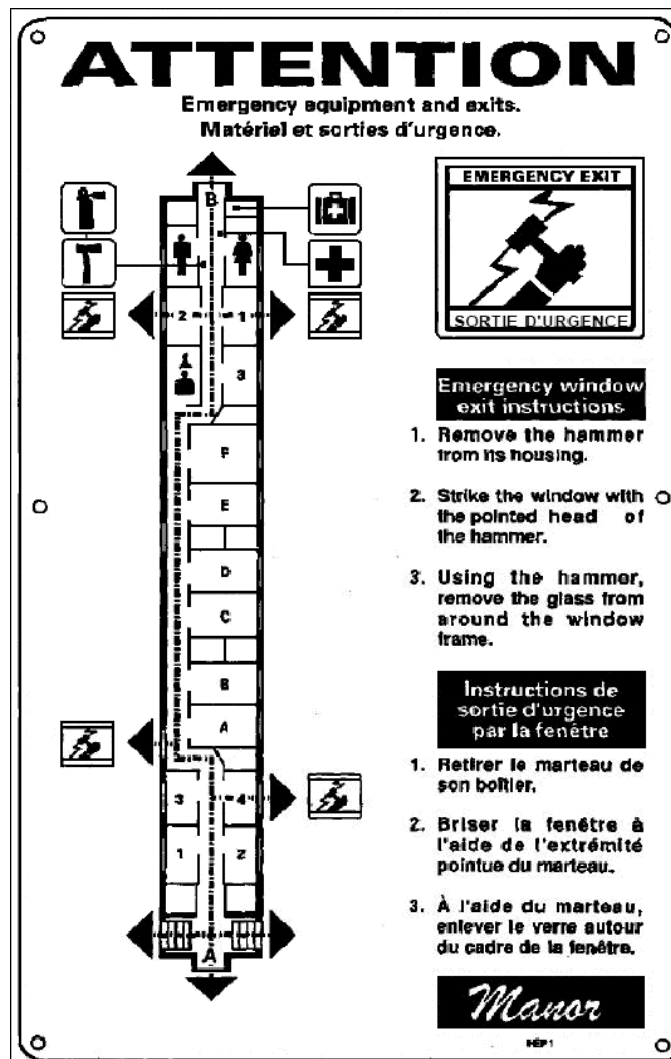
Figure 2. Placard showing emergency equipment and exits

In addition, not all sleeping compartments were equipped with emergency exit windows. Compartments A through F, which are sleeping compartments with closed doors, do not have emergency windows (see Figure 2).
